Limited To Endodontics Newsletter

May 1 2010 Volume 3

Treatment Considerations In Endodontics, Part 1

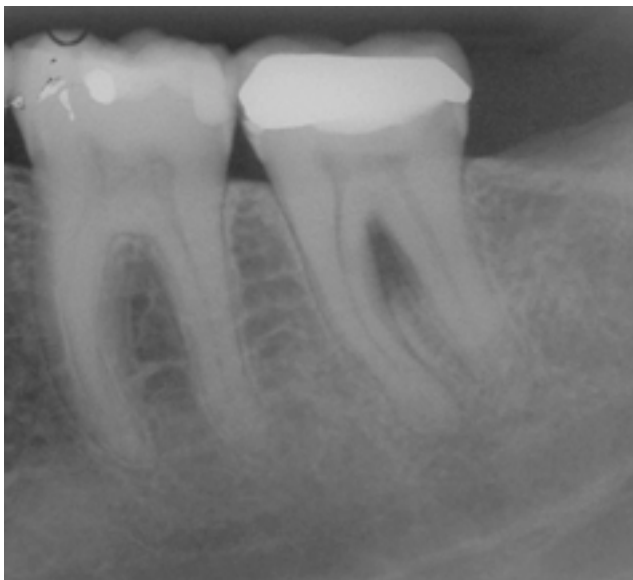
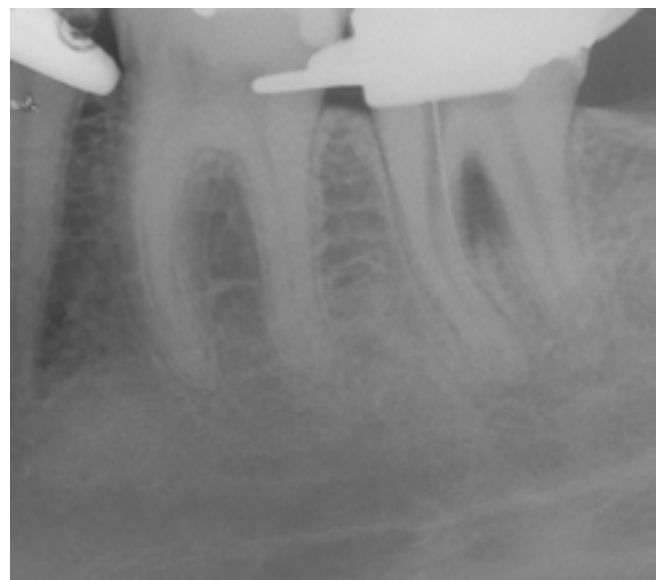
Case #1 involved a 35 year old female who presented with a sinus tract opposite tooth #18 and a history of previous swelling and pain. The initial radiograph indicated the presence of bone loss in the furcation. Periodontal probing was within normal limits. A file placed into the mesiolingual canal showed the instrument exiting into the furcation a few millimeters below the orifice as seen in the lower right radiograph.

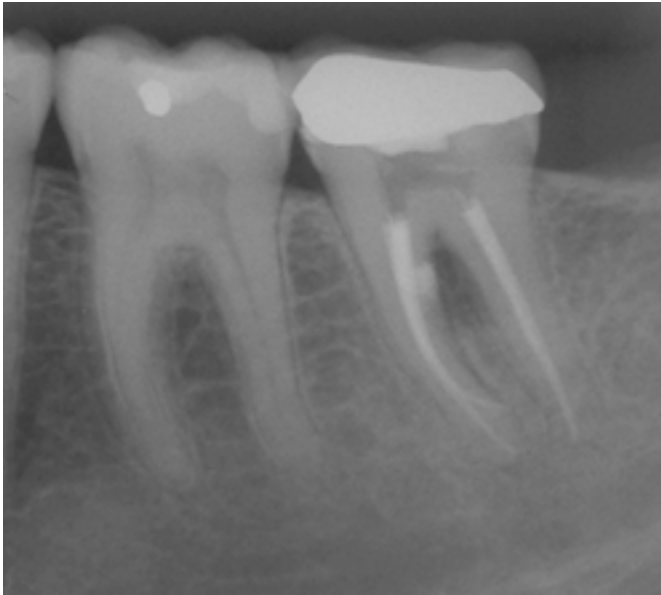
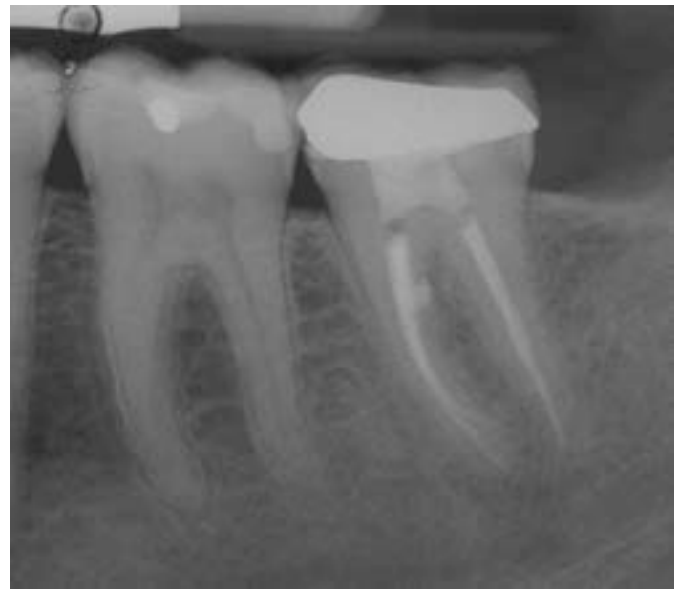
The instrument was redirected into the canal and bleeding was observed coming from an area of perforating resorption a few millimeters below the orifice. The canals were medicated with calcium hydroxide. At the subsequent appointment the sinus tract had resolved and no further hemorrhage was observed from within the ML canal. The canals were obturated with gutta percha under the surgical operating microscope with care being taken to not extrude the filling material through the resorption into the furcation. An alternative approach would be to have placed MTA before obturating the canals. The lower left radiograph shows the completed case and the lower right radiograph shows a sixteen month recall with resolution of the furcation bone.

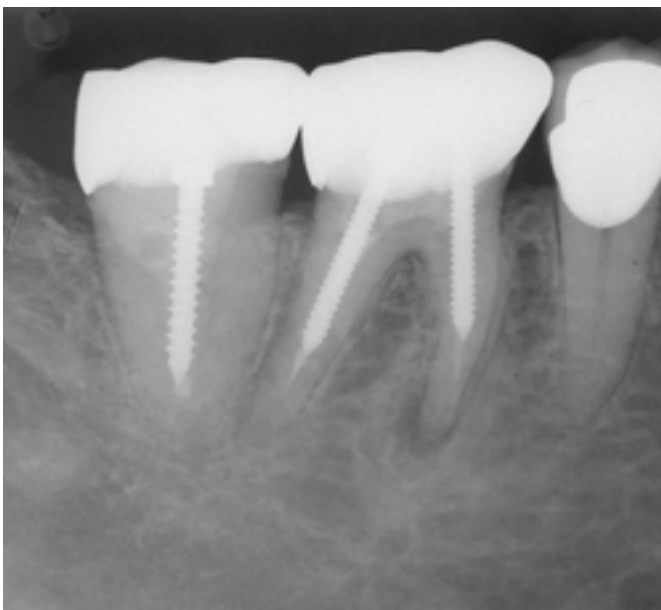
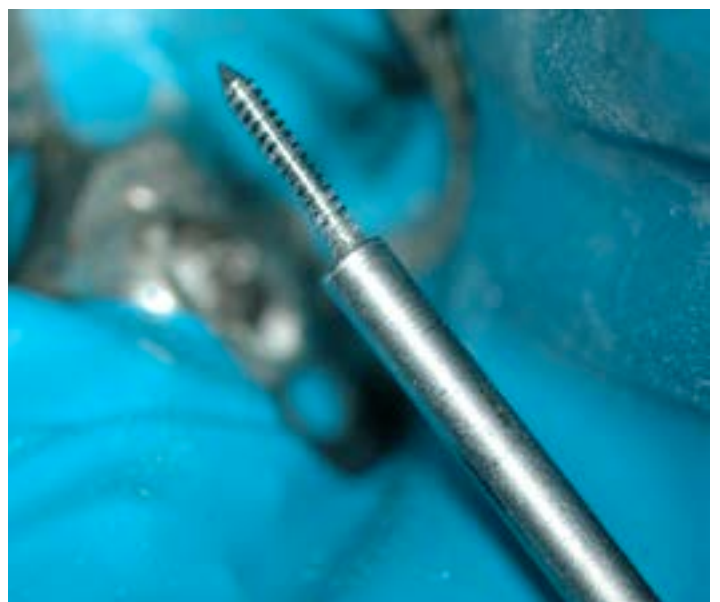
Case #2 involved a 48 year old female who presented with tooth #30 that was previously treated in Japan. Symptoms involved pain and percussion sensitivity. Each root had a large post and a surgical approach was contemplated. Since the mesial root had an area, it was decided to see if that post could be removed and if so, surgery might be avoided. The photo below shows the post that was removed from the MB canal with the Ruddle post removing tap. The next challenge would be to negotiate the canals to the apical terminus. Unfortunately the ML canal was ledged and could be instrumented only one-third of the way down.

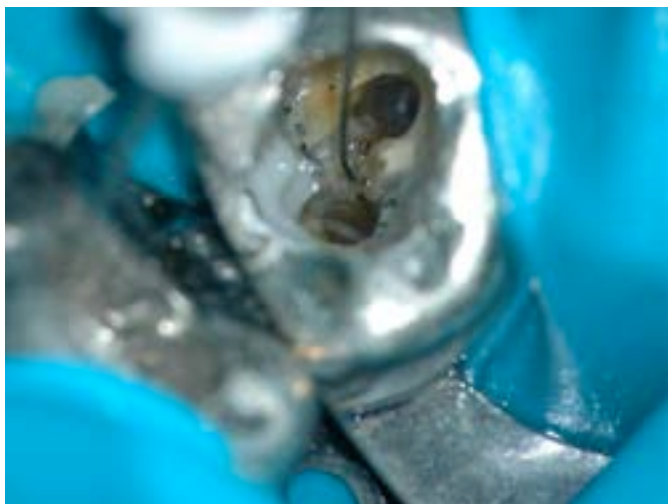
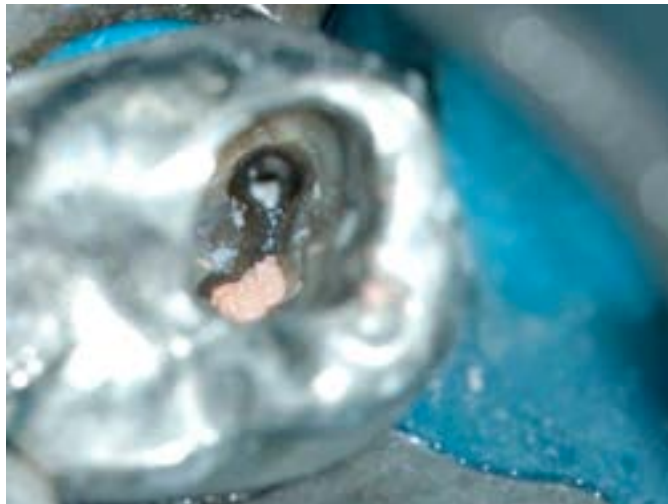
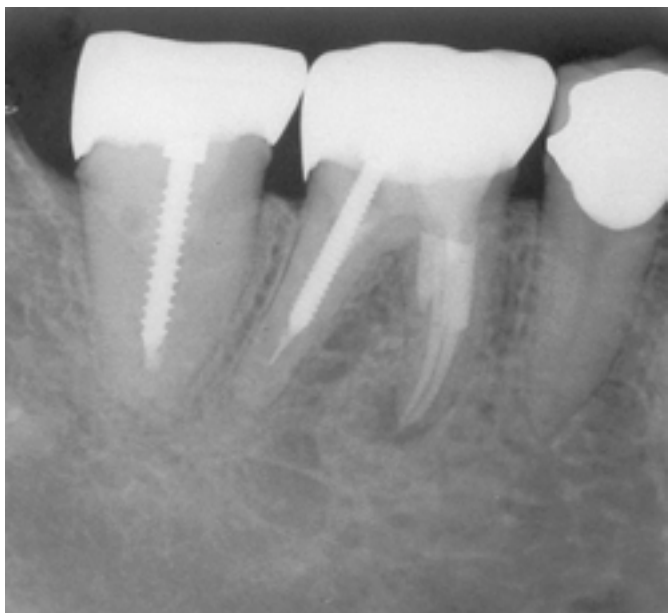
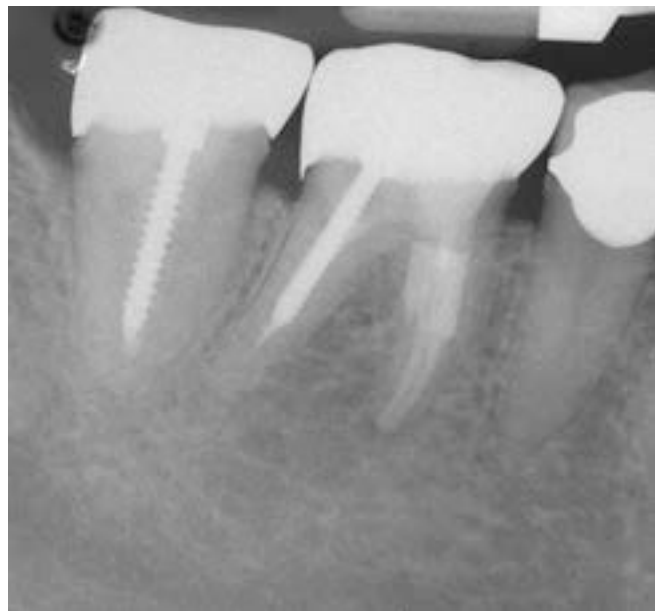
However, the isthmus that often exists between the mesial canals in lower molars was able to be located and negotiated to the apex. Rather than having a separate apical foramen, it most likely joined the ML before that point. Numerous articles have been published on locating the isthmus and instrumenting the mid-mesial canal in endodontic therapy. Not cleaning this space will result in a certain percentage of teeth that will ultimately fail and require extraction or apical surgery. The photograph on the lower left shows a file entering the isthmus and the lower right shows gutta percha filling the MB canal and sealer entering the mid-mesial through a lateral connection at mid-root. The lower left radiograph shows the completed procedure while the lower right is a two and one half year recall.

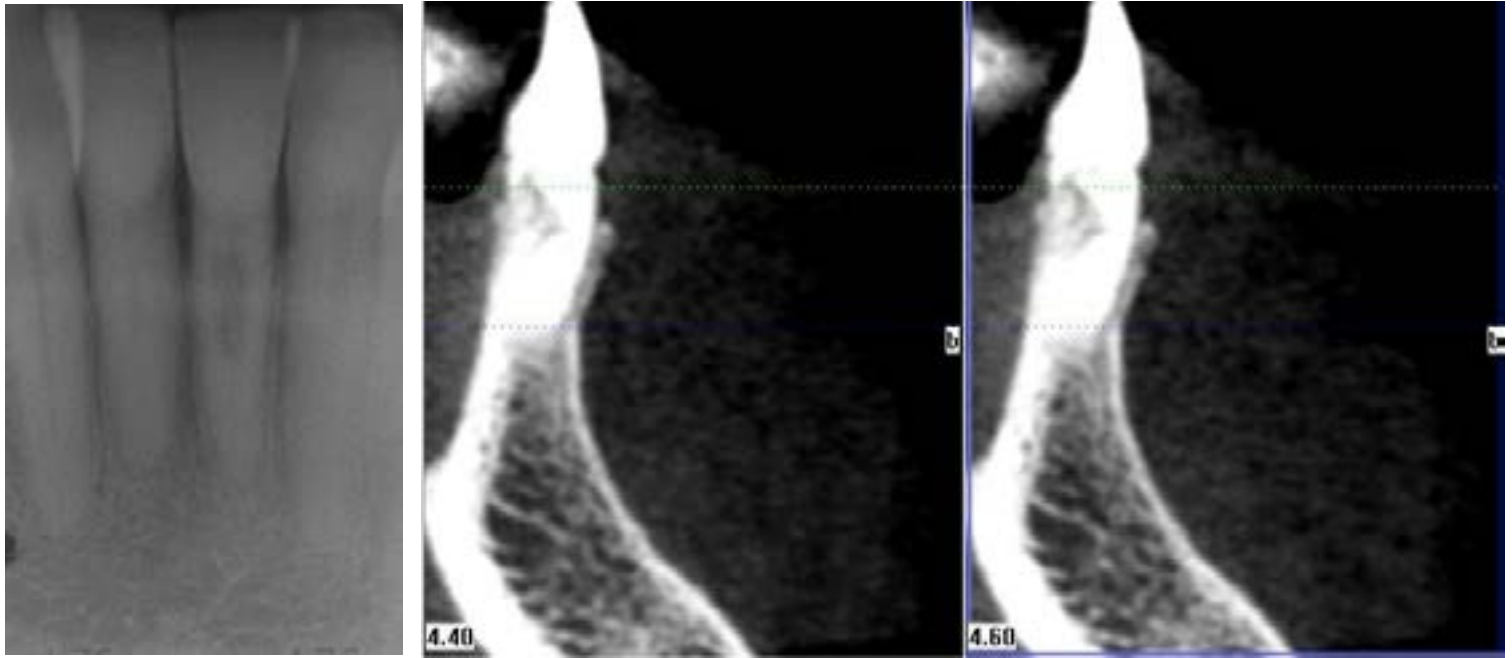
Although she was experiencing no symptoms, a watch and wait approach in these cases may be imprudent as continued expansion of the lesion could lead to tooth loss. However, there is no successful treatment for external resorption in this location. It was decided to take a cone beam scan to aid in the diagnosis. One study showed that 70% of cone-beam images provided additional clinically relevant information not found in conventional periapical radiographs.²

The lower left radiograph shows that it is difficult to determine whether the resorption is internal or external. The scan indicates that the resorption is external and it was decided that no treatment was indicated. Treatment would have required endodontics, crown lengthening and external repair of the defect.

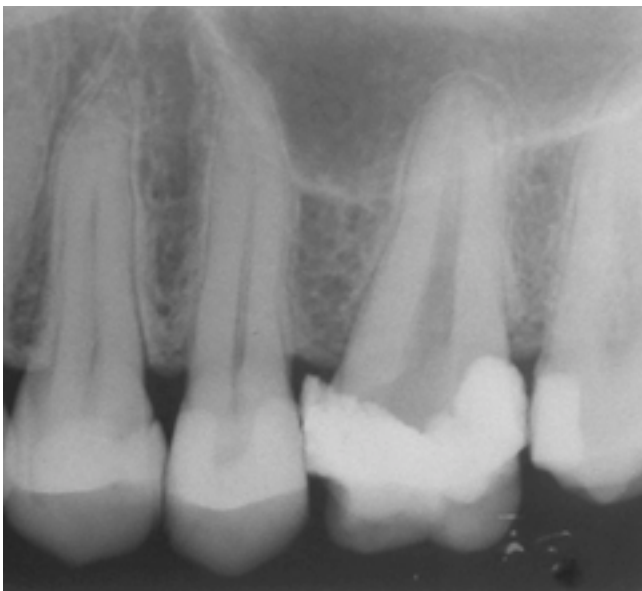
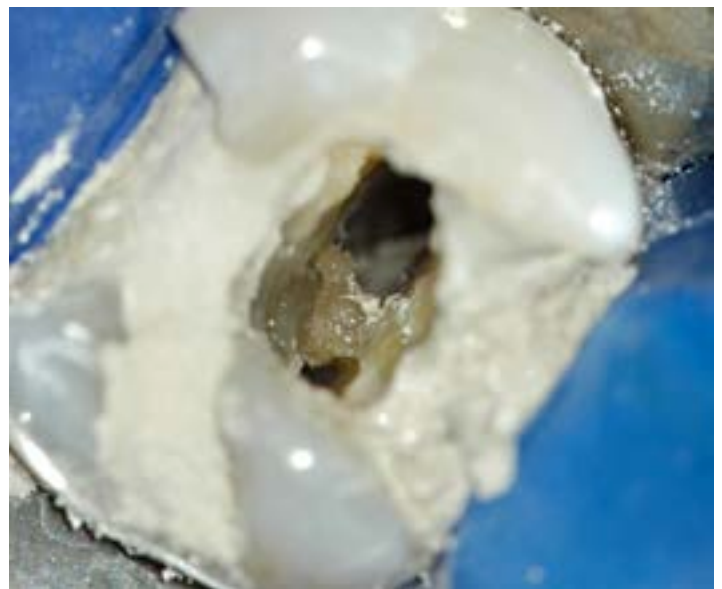
Case #4 involved a 37 year old female that had a root canal procedure started by their general dentist. Although the canal anatomy seemed simple upon initial radiographic inspection, the canal was large and filled with pulp and pulp stones that were not easily removed with conventional instrumentation. Without a microscope, it was difficult to determine if there was more than one canal present. The lower radiograph was the tooth as presented and the photograph shows the tissue still present. The tissue was removed with ultrasonic instrumentation along with a braiding and extracting technique with hedstrom files.

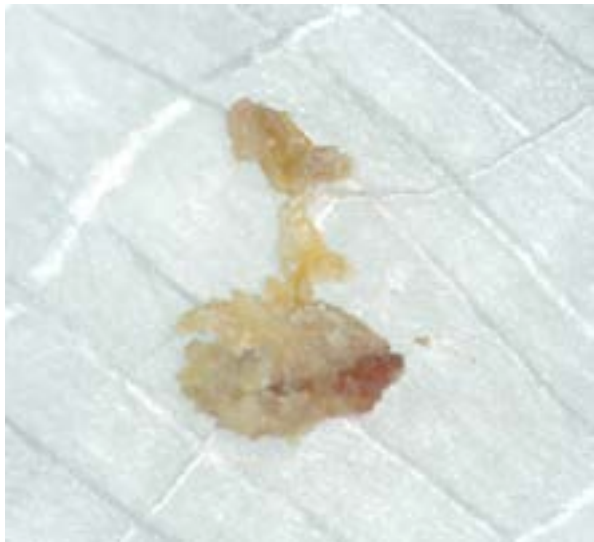
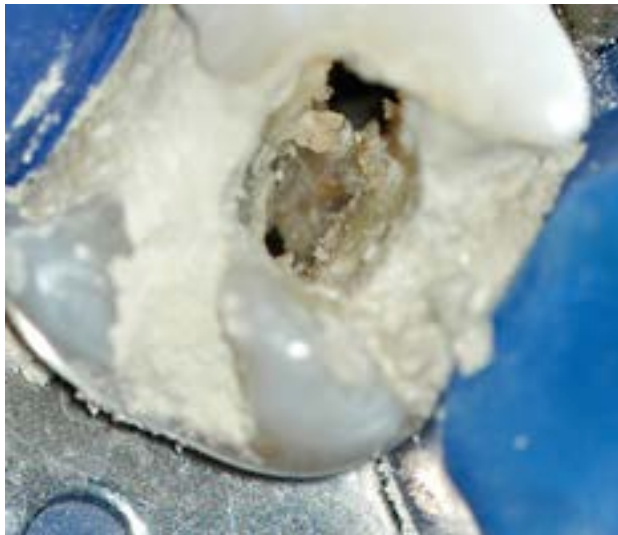
The lower left image shows the tissue that was removed while the lower right image shows the remaining debris still present. After the remaining gross tissue was removed, microscopic visualization still showed

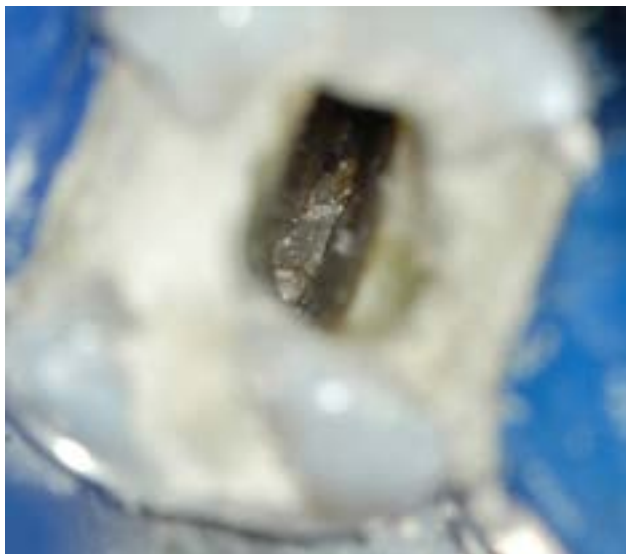
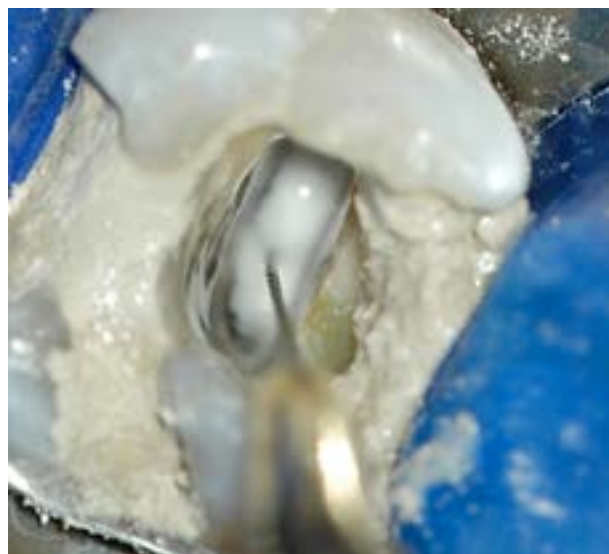
debris packed at the apex, lower left photo. Using passive ultrasonic irrigation, lower right photo, the

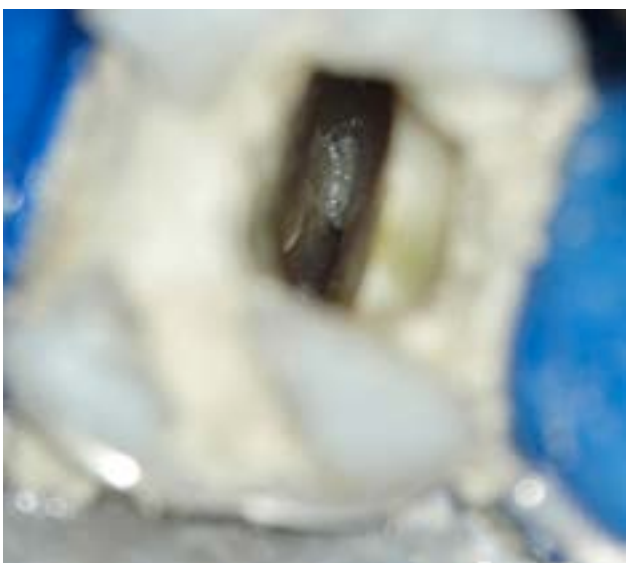
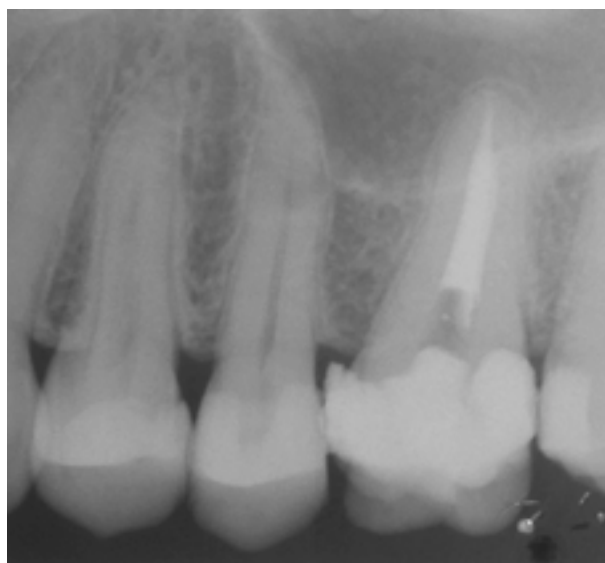
remaining canal was now free of debris, lower left, and the tooth was obturated.
